| REPORT DOCUMENTATION PAGE | | READ INSTRUCTIONS BEFORE COMPLETING FORM |
|---|---|---|
| 4. TITLE (and Subtitle) National Program of Inspection of Non-Federal Dams Tennessee. Houser Creek Dam No. 2 (Inventory Number TN 13114) near Union City, Tennessee, Obion County, TN., North Fork Obion River Basin. | | 5. TYPE OF REPORT & PERIOD COVERED Phase 1 Investigation Report |

ABSTRACT

PHASE I INSPECTION
HOUSER CREEK DAM NO. 2
OBION COUNTY, TENNESSEE

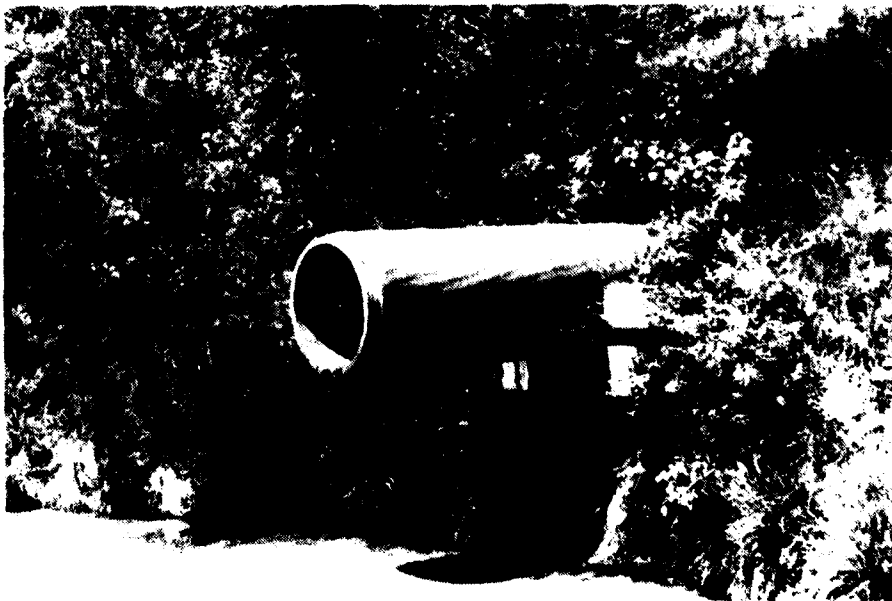
8. 36 inch outfall pipe and plunge pool.

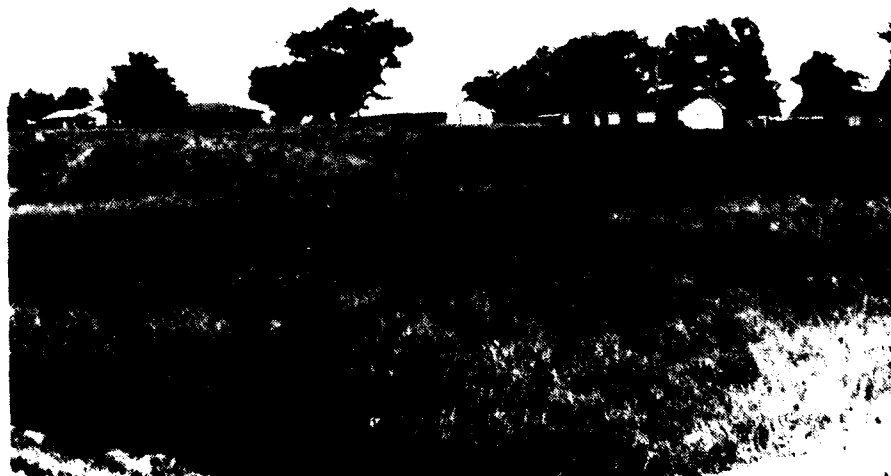
The emergency spillway is located in the left abutment. The general condition of the emergency spillway is fair. The entrance channel is grown up with trees and other small brush and in the control section, trees are beginning to grow. The exit channel presently is clear with the lower section under cultivation.

10. Control section of emergency spillway in east abutment.

- a. Plan and supervise the removal of all trees and underbrush from both slopes of the dam and emergency spillway.
- b. Determine if unsafe conditions exist on both slopes of the embankment and design and supervise construction of remedial measures to provide a safe embankment, if necessary.
- c. Investigate the service spillway system and suggest corrective measures if needed.
- d. Evaluate the stability of the dam with earthquake loadings.
- e. Develop a regular program for inspection and maintenance of the embankment and spillway on at least an annual basis.

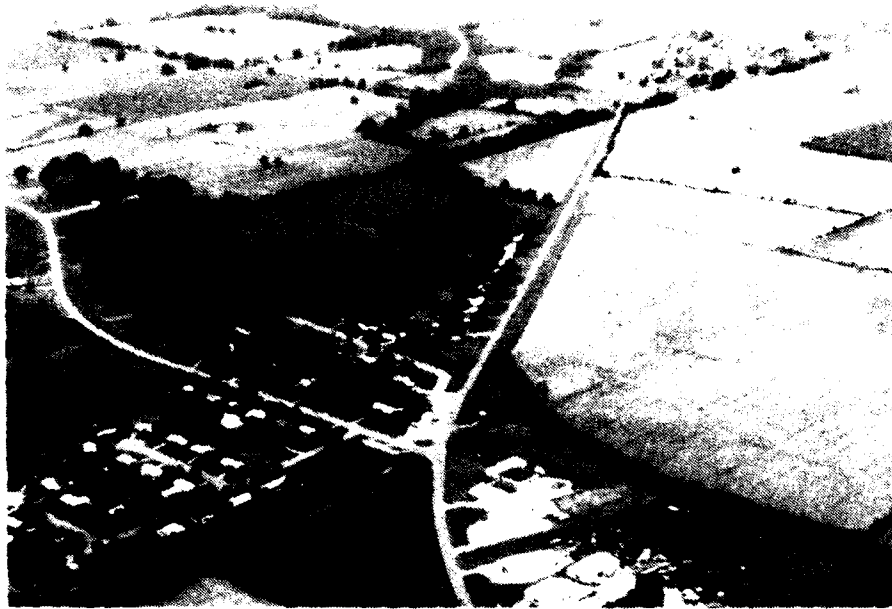
3.1.5 Downstream Inspection and Hazard Classification - The Houser Creek Dam No. 2 has a hazard potential classification of high. There are approximately ten houses located 4500 feet below the dam that are in the probable flood path in the event of a failure of the Houser Creek Dam No. 2.

11. Subdivision immediately below Houser Dam No. 2.
